Coco

0.1 Southern Black Rhino
(*Diceros bicornis minor*)
Born 1 Dec 1990

If The Boot Fits!

By Justin Smith
Senior Animal Care Specialist
Fossil Rim Wildlife Center

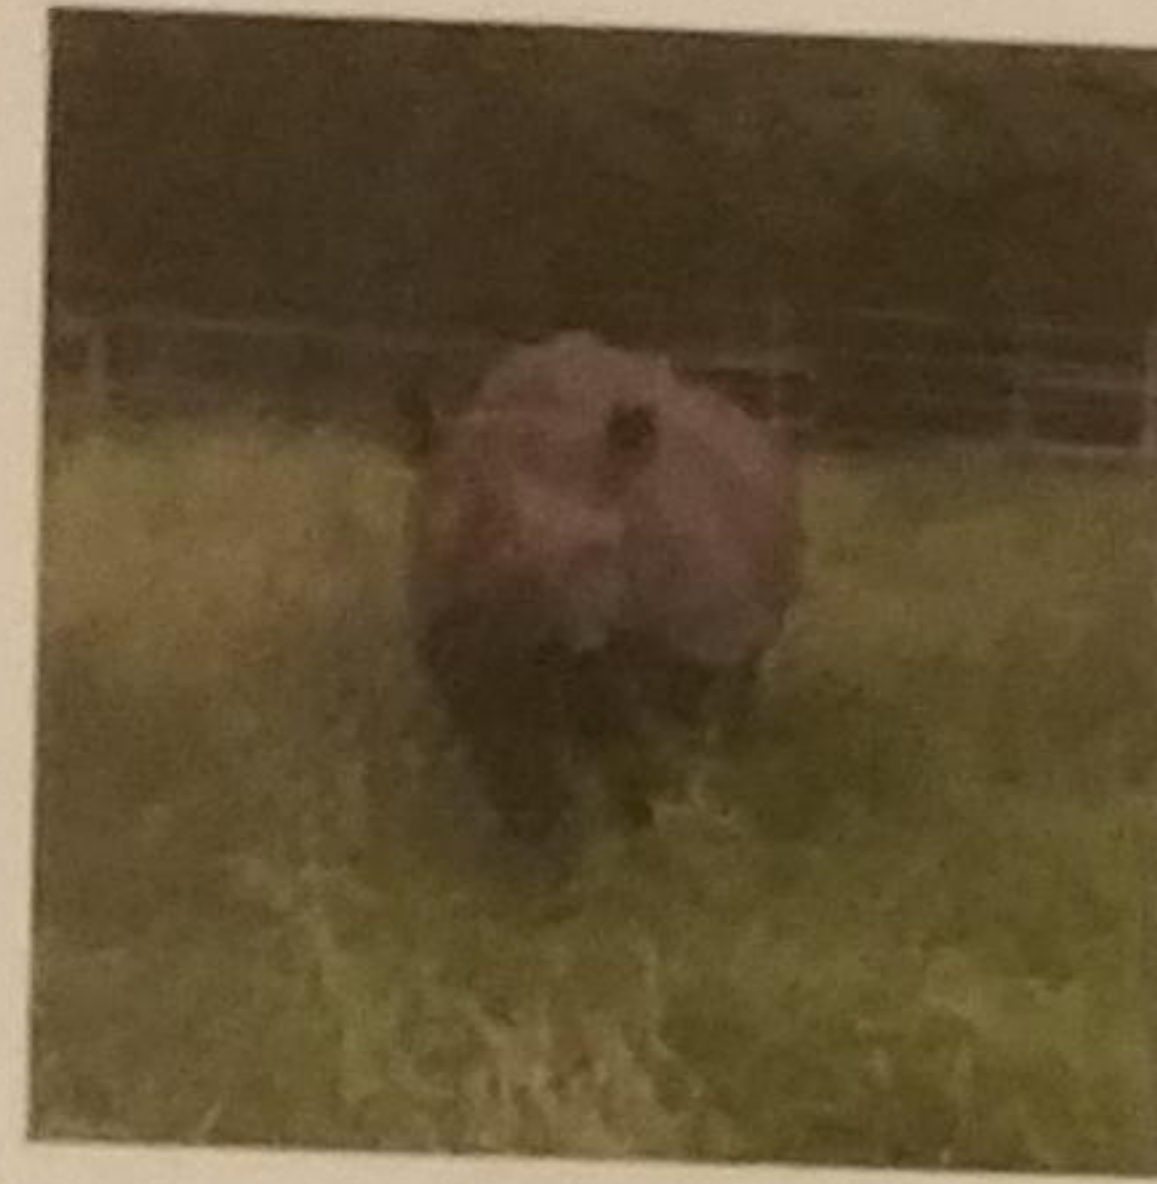
Since 1995 Coco has had defect wounds appear along the hoof sole and pad junction of the medial toe on her front feet.

1995-1996 – Shortly after arriving Coco started propping her foot and had swelling along the coronary band. Soon the first defect was noted on her front right foot. An ultrasound was performed and revealed a 2 inch deep tract. It was treated with debriding, cleaning, and packing with antibiotics. Defect resolved in less than a year.

2006 – Puncture wound was found in the sole. The tracts were 1 ½ inches deep. Wound healed slowly over the course of the year with cleaning and packing with antibiotics.

2009 – When the defect wound resolved, a new defect would flare up. Treatment became more aggressive with immobilizations for radiographs, antibiotic perfusions, fistulagram, and heavy debriding, followed by packing the wound with antibiotics. Boots were created and applied with limited success. During one of the immobilizations a small wood like object was removed from inside the wound. After this the wound began to heal and resolved by June.

2013-2014 – Defects in the pad of the front right foot were noticed. They were treated with cleaning and topical medication but they continued to get worse and required immobilizations for aggressive treatment.

2015 – A new defect wound was found on her front left foot as a result of her having to redistribute her weight off of her front right leg. We began immobilizing her every two weeks to debride, clean, perfuse, and apply antibiotics. The feet would be wrapped and then have the black and white rubber boots applied. The boots must be taped on and would only stay on for 3 days. (photo bottom center)

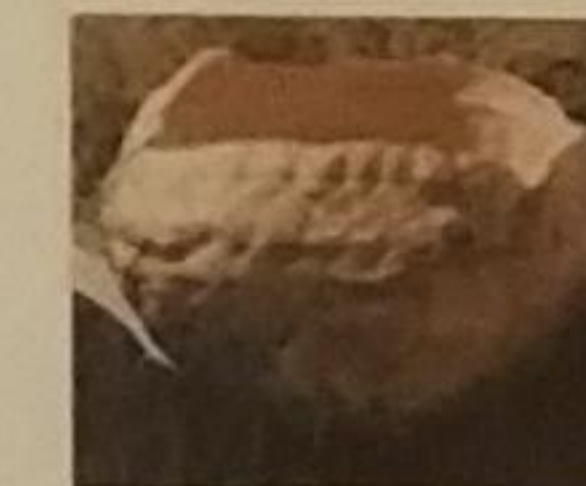
White rubber boot – created by our veterinarian staff

- Weight is reasonable (7lbs.)
- Does not surround the entire foot
- Must be taped on
- Can with stand a rhino's abuse
- Only stays on for a couple days

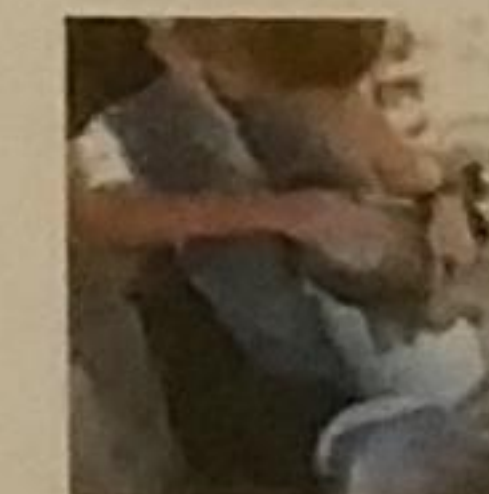
Duct tape boot – Improvisation by our veterinarian staff

- Light weight
- Thickness can be varied
- Temporary

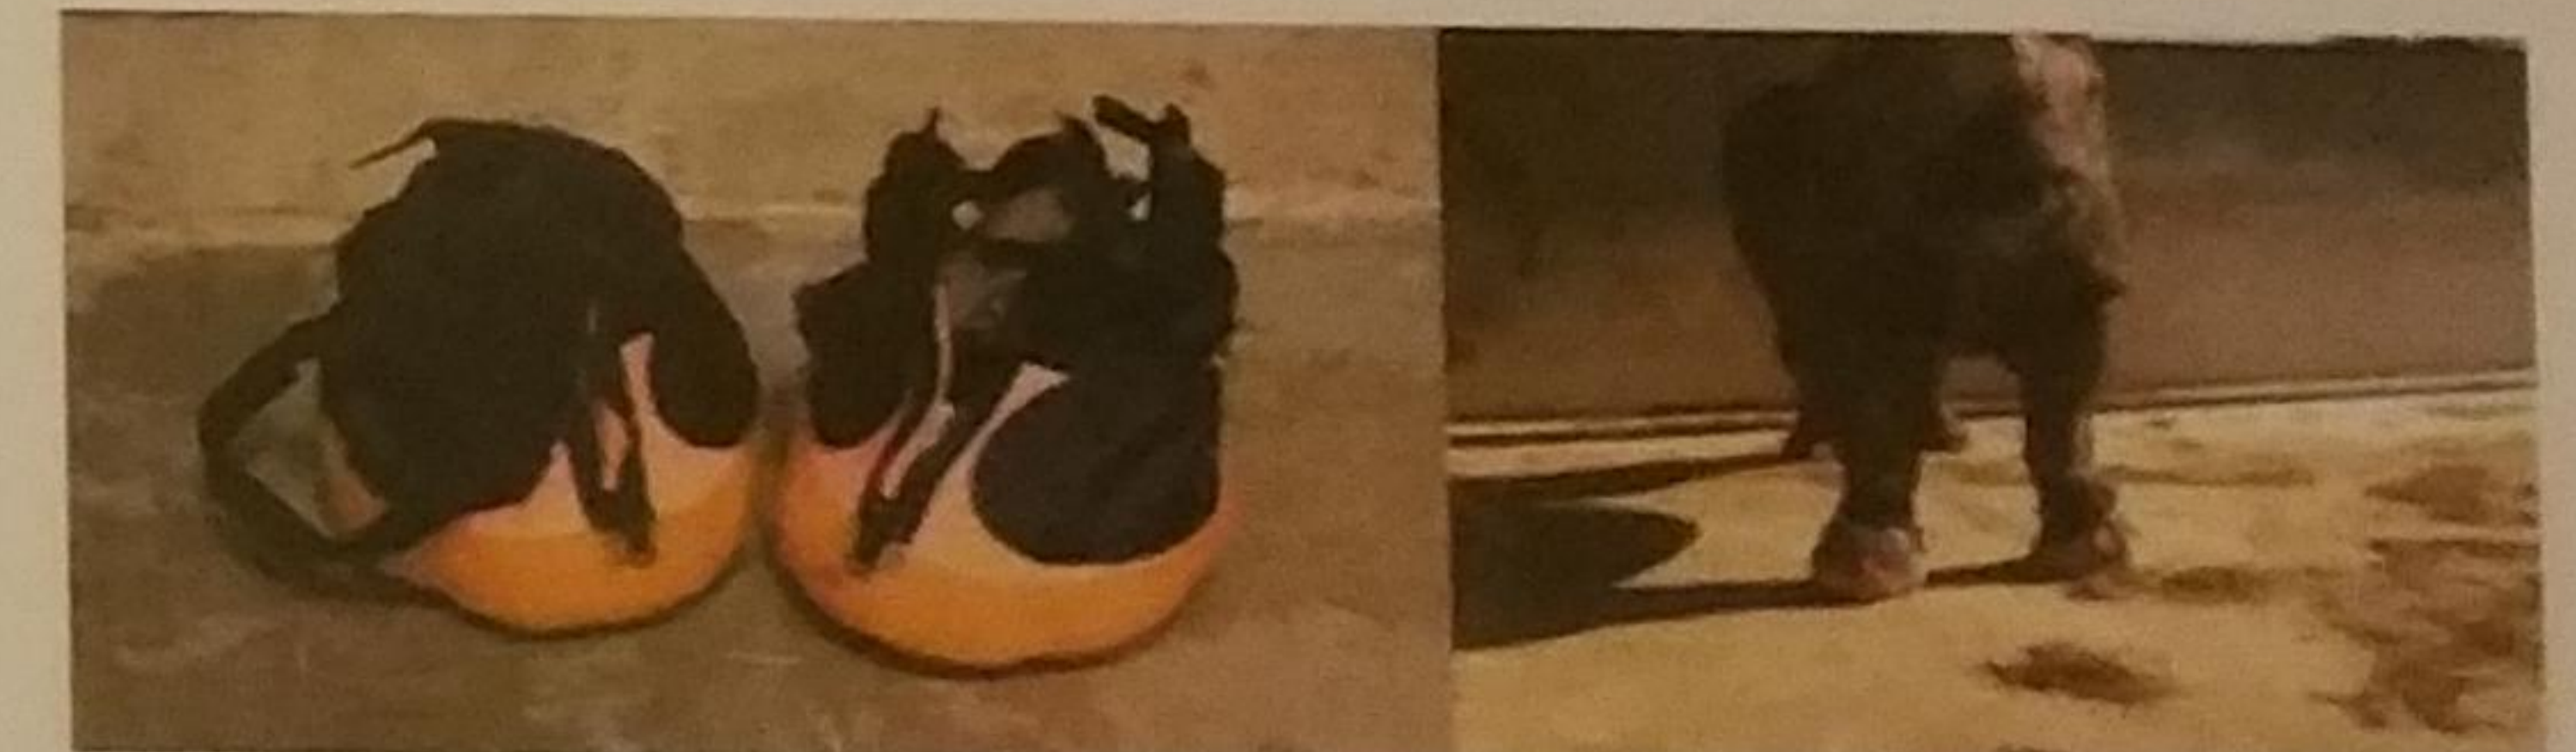
Christine and Brian take the molds and create a cast of her feet. From the cast they build a custom formed fit boot.

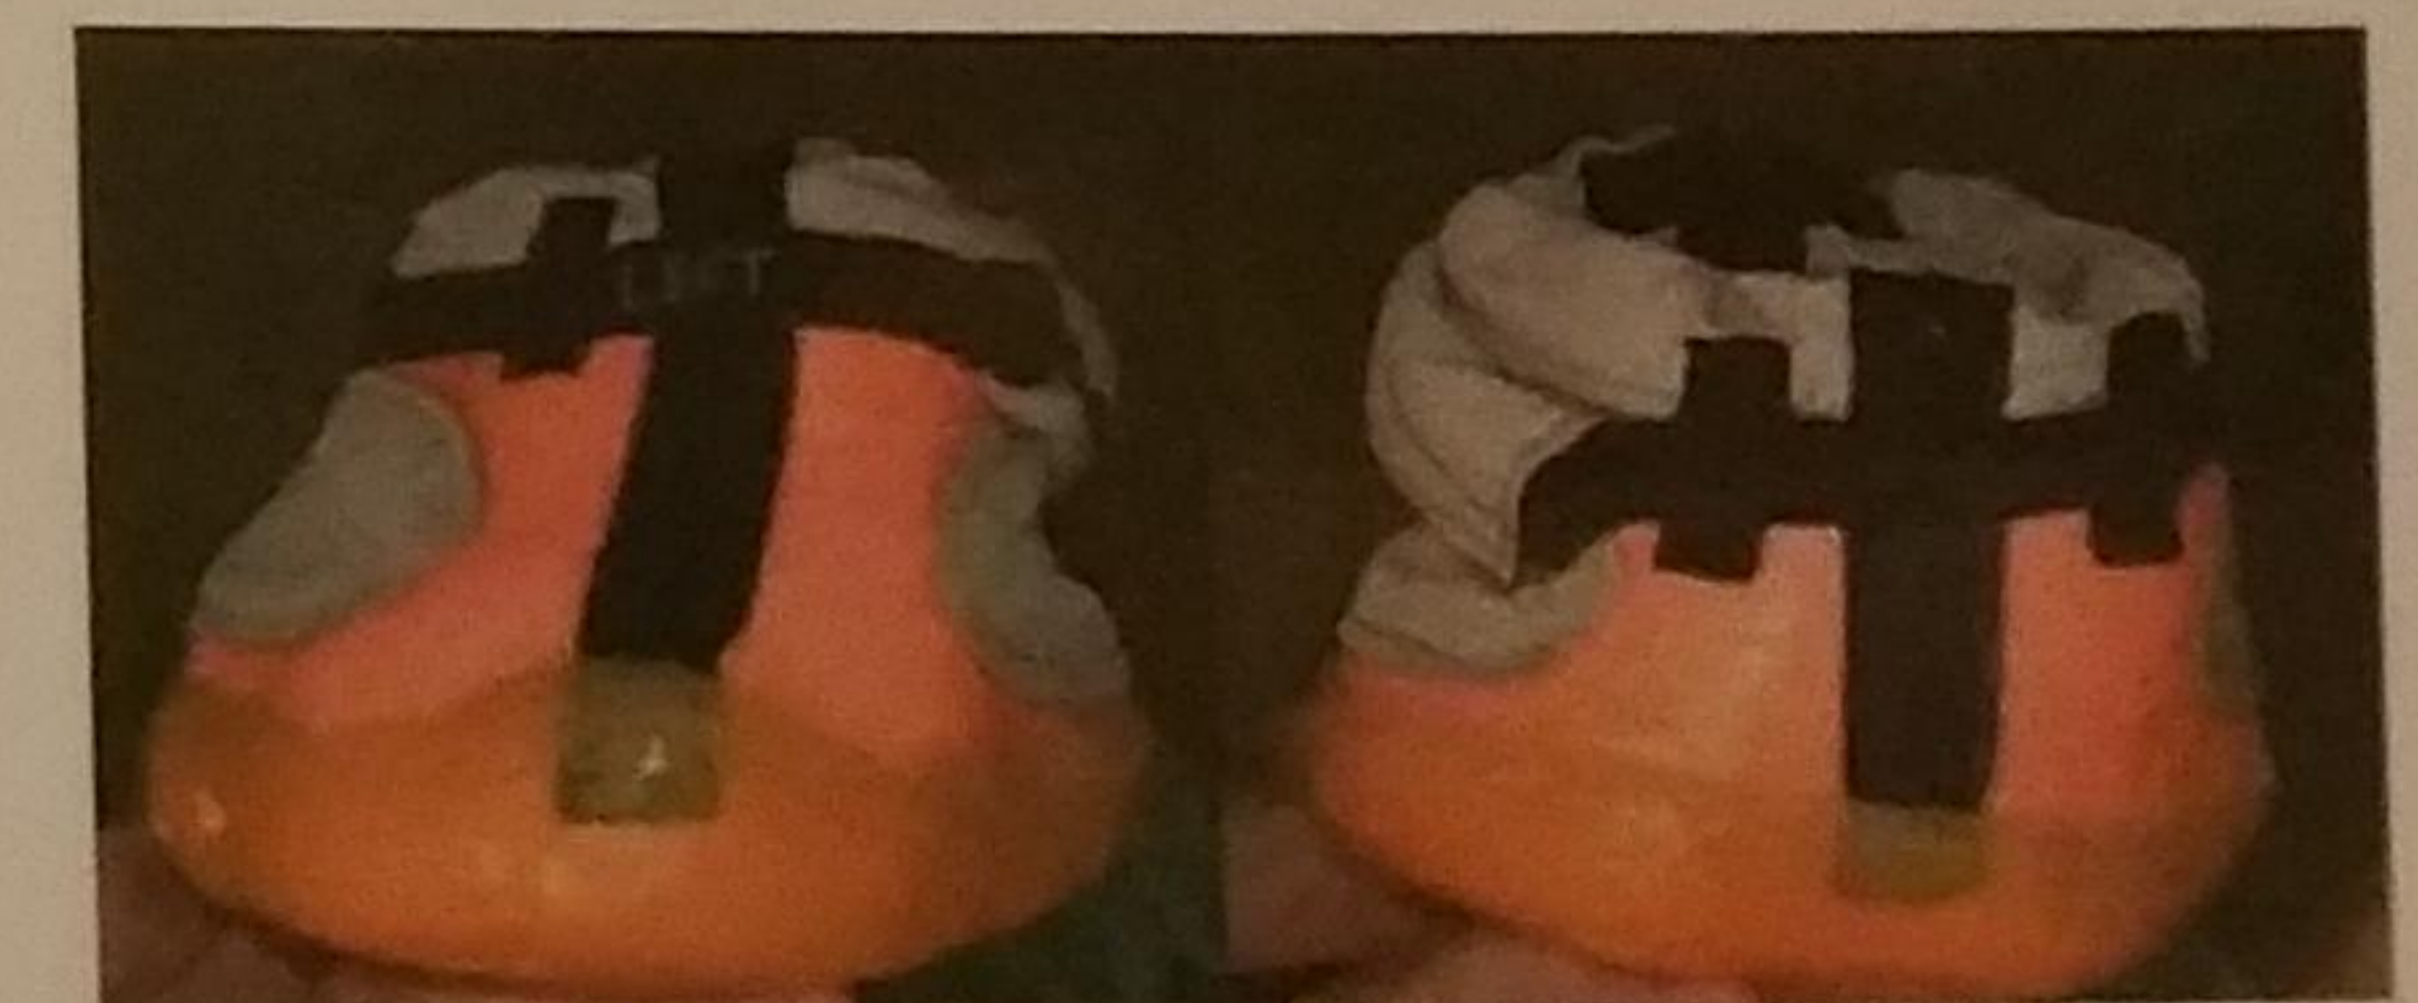
Diceros Boots made six pairs of boots for Coco. After each pair was field tested, the boots would be evaluated. Then Fossil Rim Staff and Diceros Boots would brainstorm how to make improvements to the design. Each subsequent set of boots were made with improved modifications.

Pictured above is the 1st generation boots and Coco shown field testing the 1st generation. Below is a 5th generation boot

Nov 2015 – Christine returns with Coco's first pair of boots. The first set of boots only lasted 6 days before they began to deteriorate and eventually were removed.

2015-2016 – Over the next several months 6 sets of boots were made. Each set of boots lasted about 2 weeks. Only 2 boots were successfully removed before they were destroyed beyond repair.
