THE ROYAL MURALS OF RAJASTHAN

Art in Peril

JOACHIM BAUTZE

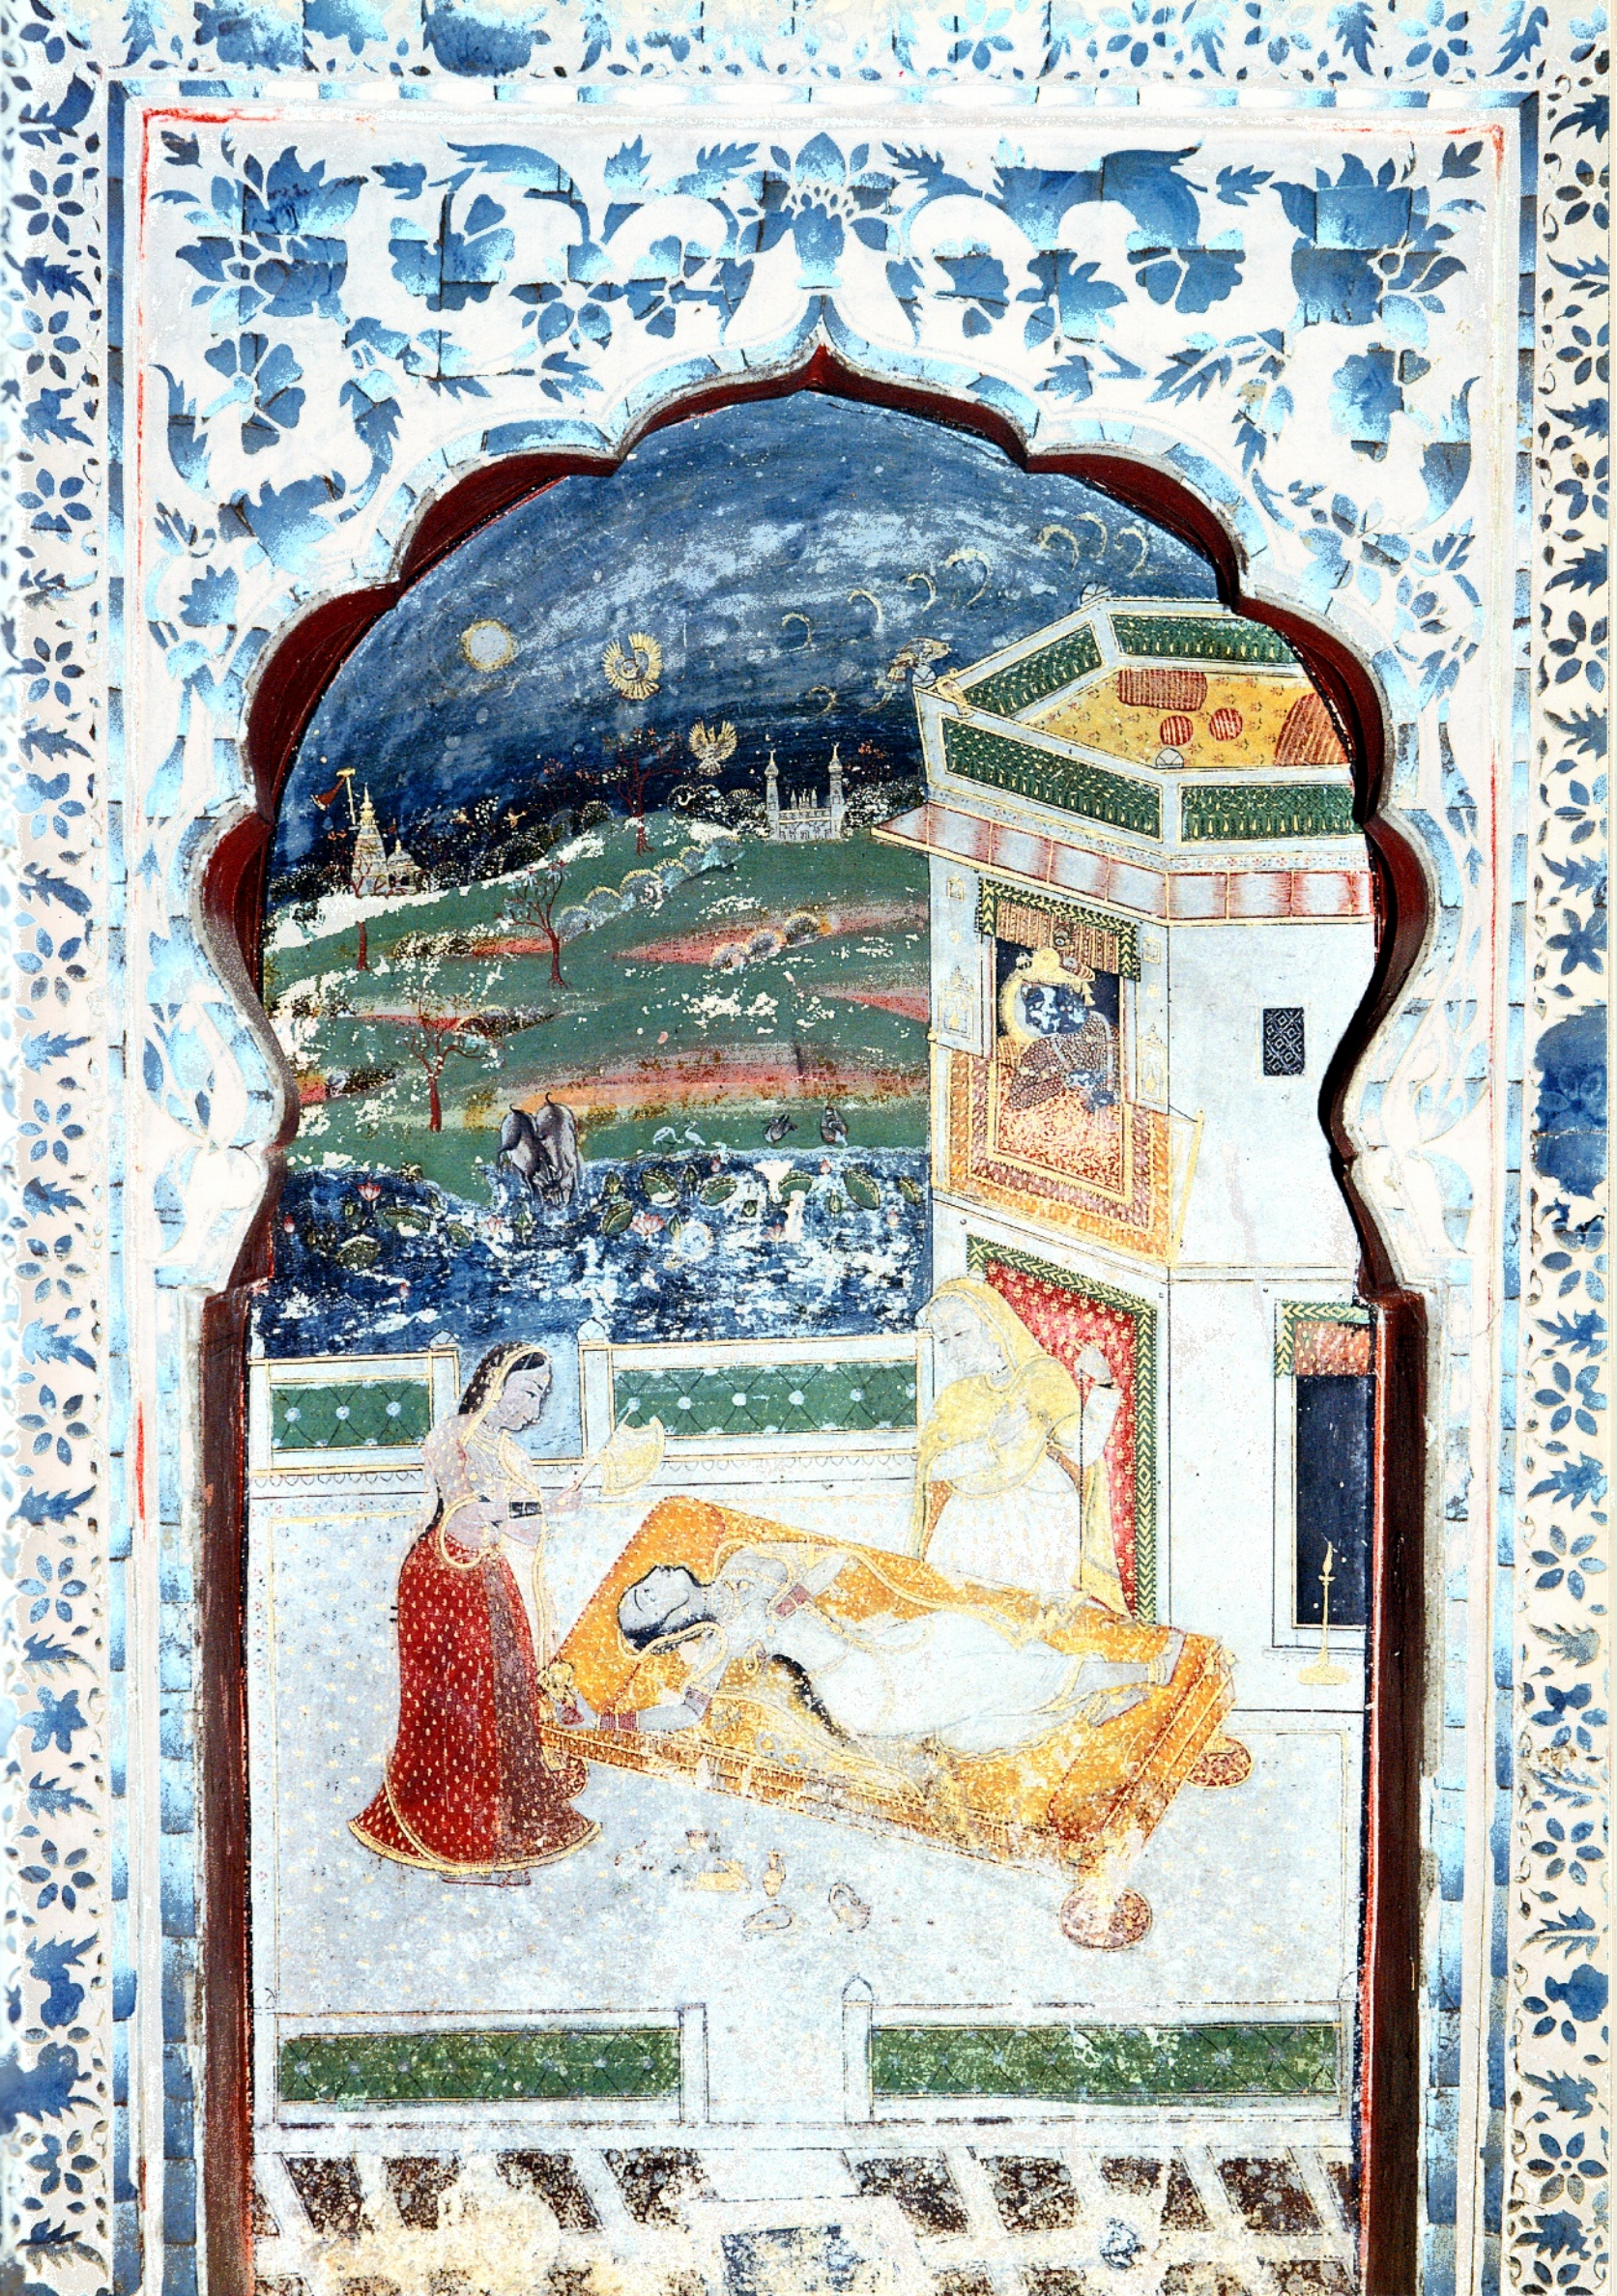
2. *Previous page: A lovesick lady pining for Krishna, her lover. First floor, eastern room, western wall of the Jhala ki Haveli, Kotah Palace. 78 x 45cm (31" x 18"). Photographed in 1983.*

The earlier photographic record of another example shows a love-sick heroine lying on a bed on a terrace, pining for her divine lover Krishna, who looks down from a palace window apparently unnoticed by the heroine (2). A serving-girl waves a fan above her head, while a duenna resting on a long stick tries to talk to her. This night scene is illuminated by a burning candle and the full moon, the light of which is reflected on the minarets of a mosque, and on the gilded top of the *shikara* (tower) of a Hindu temple set against the dark blue sky on the horizon. A decade later the painted plaster had suffered damage both by repeated blows to the surface and by scratching. Gold leaf originally applied to the two birds, the temple and the mosque had been scratched away. The name Ajay had been scrawled on the painting in white chalk.

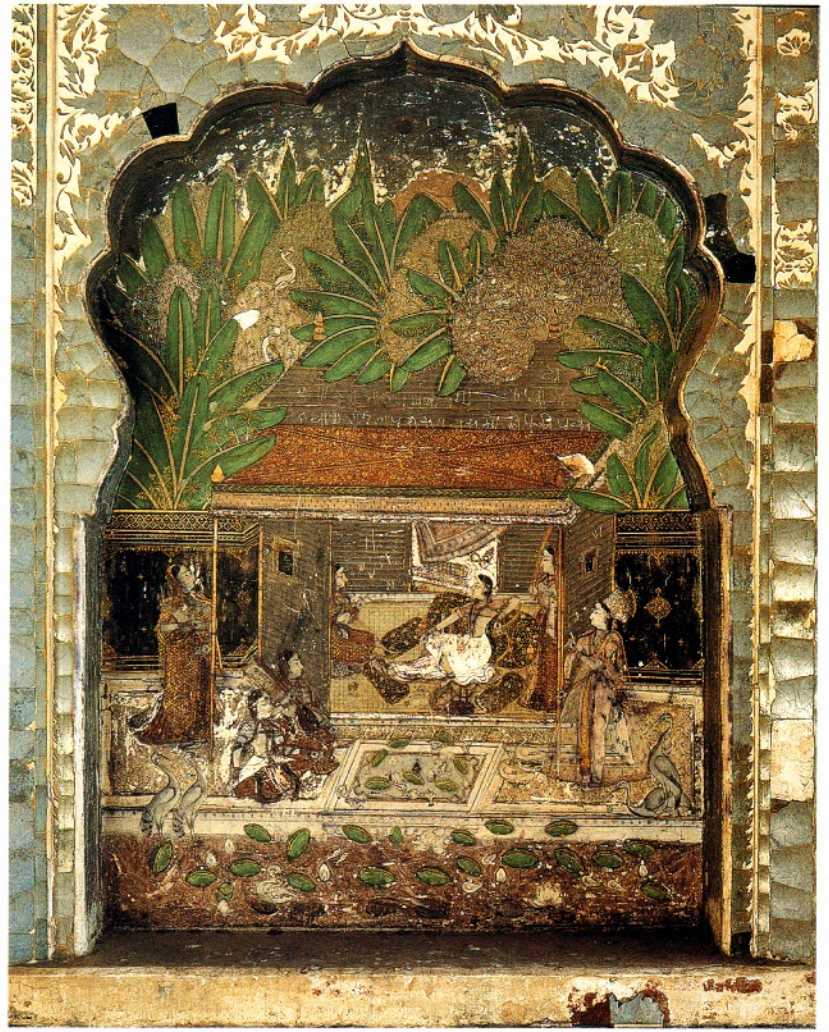
5. A Lady entertained by musicians, eastern verandah, eastern wall, southern niche. 90 x 63cm (36" x 25"). Photographed in 1983.

One of these murals shows a high ranking woman sheltering from the sun's heat in a hut with an awning (5). She is being entertained by two musicians seated outside the hut in addition to four ladies-in-waiting. The later photograph of the same mural shows that its upper part had completely broken away, with only a small section of the lower part still intact but seriously cracked (6).

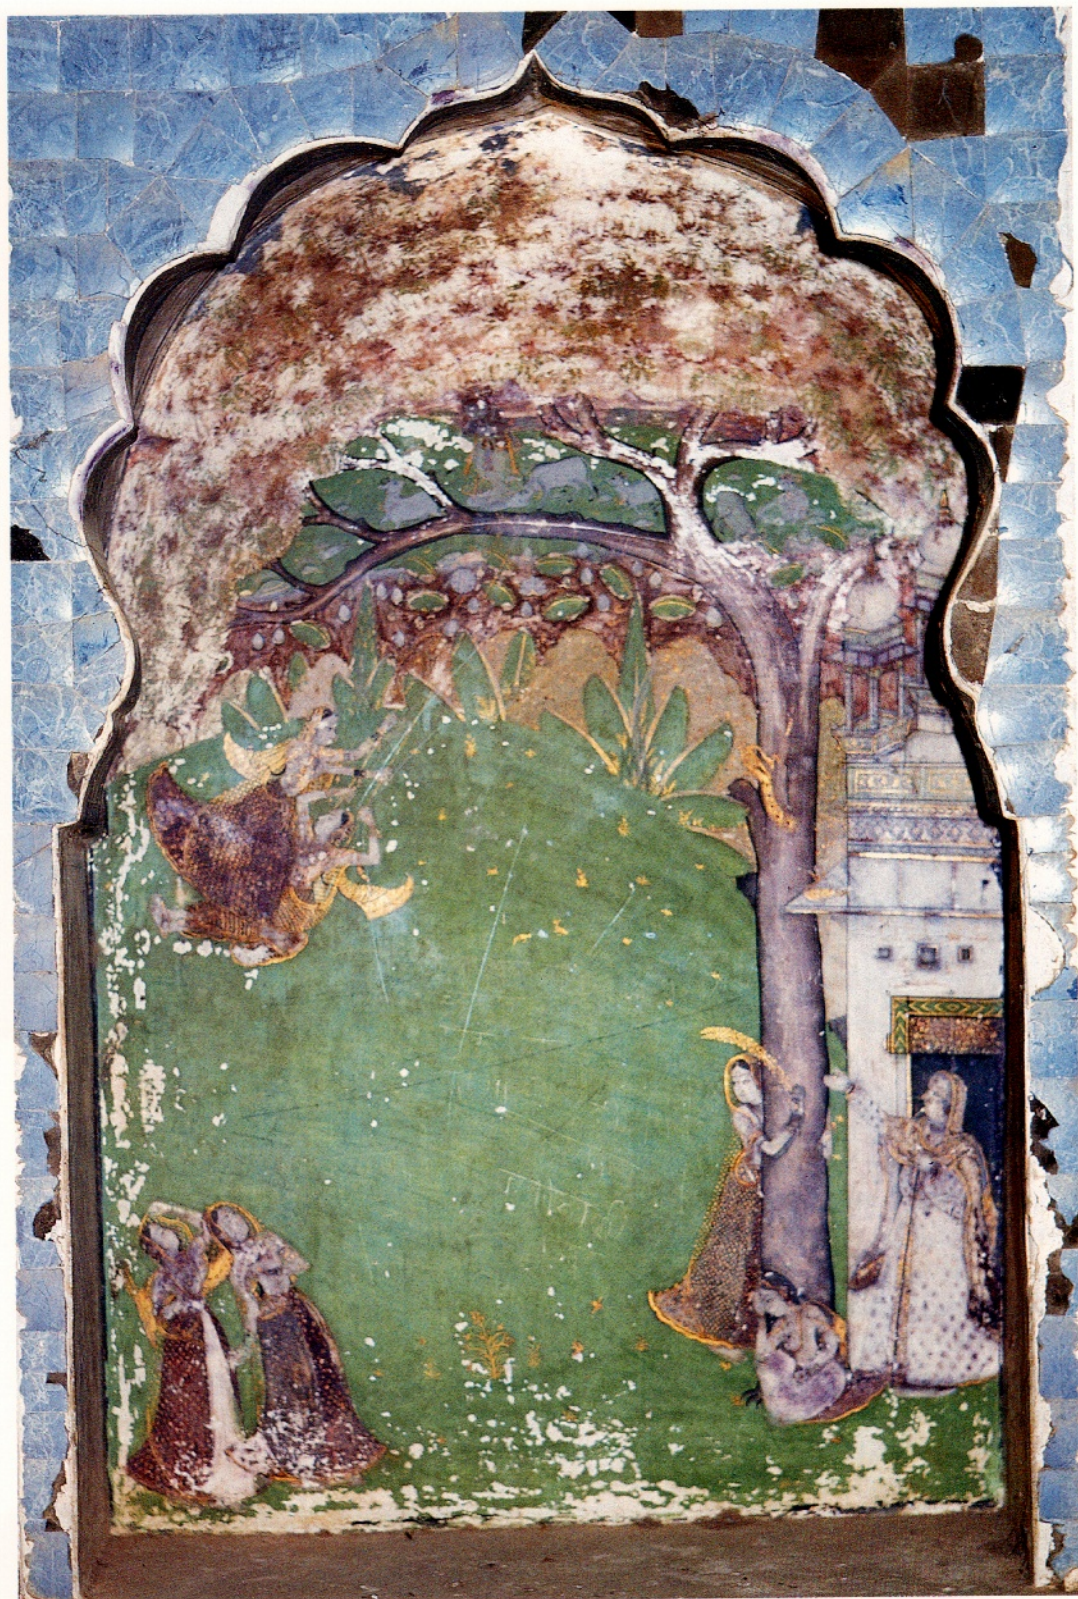
7. Two ladies on a swing, eastern verandah, northern wall, central niche. 86 x 53cm (34" x 21"). Photographed in 1983.

A second example shows two ladies on a swing suspended from the branch of a large tree next to a palace structure (7). Two more ladies witness the scene from below the swing, while another woman embraces the trunk of the tree. An old duenna appears through the door of the palace and points at the swing. A kneeling woman at the bottom of the tree looks distressed. The photograph taken in 1993 reveals that the left half of this mural had by then been completely destroyed (8). A third example shows Krishna carousing with ladies

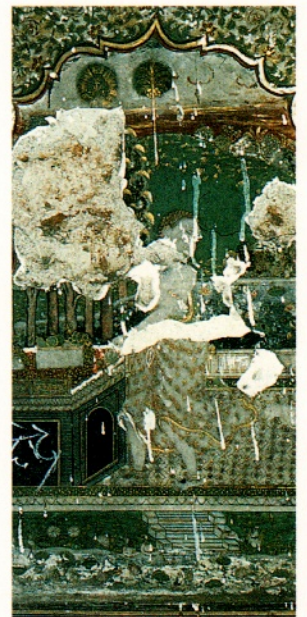
14. Detail of 13 showing extensive surface damage. Photographed in 1993.

European-inspired Fortuna, without understanding the details. The mural was already partly damaged in 1983 when an area of painted plaster had flaked off. By 1993, however, large areas of the plaster had been damaged (14). In addition, there were signs of recent graffiti and white pigment appeared to have been thrown over the entire wall, leaving extensive streaking.
